# AVN-20211202 Problematic MEMS Oscillator

<b>Company</b>	Trenz Electronic GmbH
<b>AVN Number</b>	AVN-20211202
<b>Title</b>	Problematic MEMS Oscillator
<b>Subject</b>	Information and remedy concerning problematic MEMS Oscillator
<b>Issue Date</b>	2021-12-09

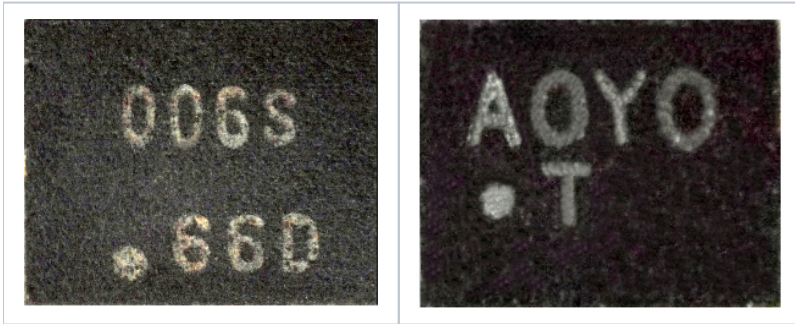
If you encounter any of the above described issues please use Schematic (SCH-TE....pdf) and Assembly Diagram (AD-TE....pdf) for the corresponding product to locate the MEMS oscillator. Mentioned documents are accessible via [Trenz Electronic download area](#). The table below shows example chip markings of MEMS oscillators. Letters may differ, but arrangement is specific for the used part.

possibly affected	not affected
DSC6111MI2A-025.0000	SiT8008BI-73-18S-25.000000E
