AVN-20220701.0 TEB0911 RTC does not work

Company	Trenz Electronic GmbH
AVN Number	AVN-20220701.0
Title	AVN-202207010.0 TEB0911 RTC does not work
Subject	Information about RTC usage
Issue Date	2022-07-01

Affected Product
TEB911-01-*
TEB911-02-*
TEB911-03-*
TEB911-04-*

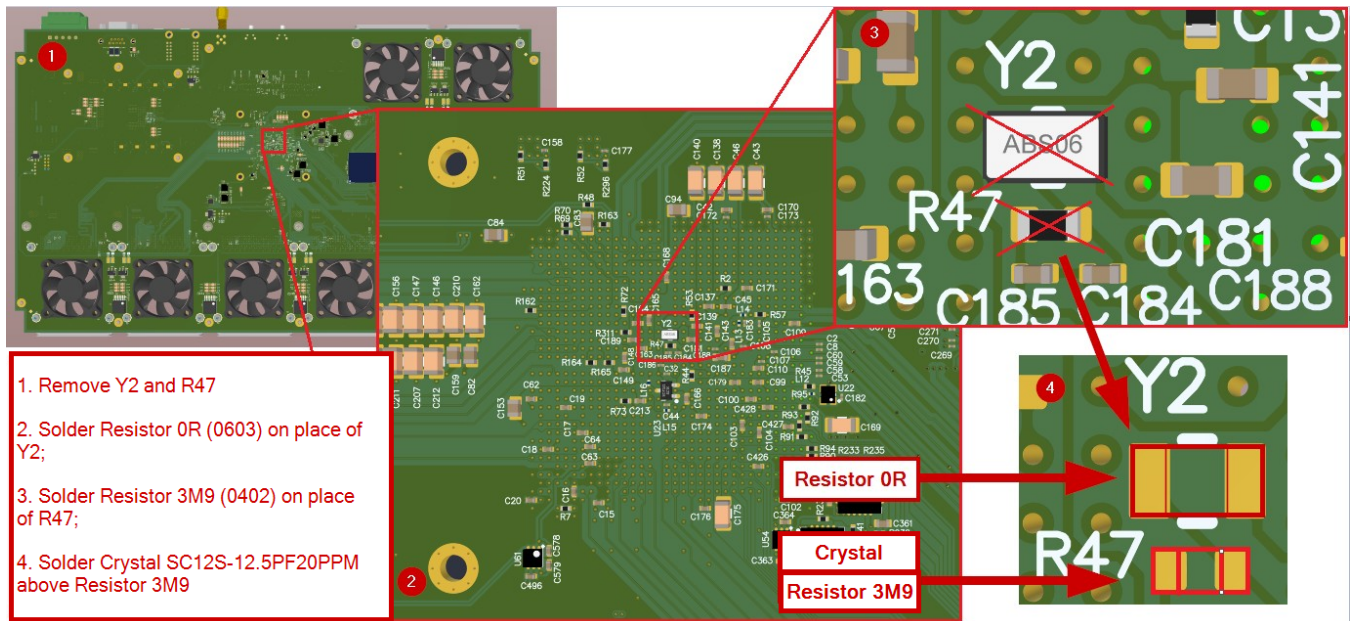
Procedure to fix RTC issue

The HW wiring for the RTC is incorrect. This leads to the fact that the RTC initializes, but the time does not change.

Problem can be solved with following HW changes:

1. Remove Y2 and R47
2. Solder Resistor 0R (0603) on place of Y2
3. Solder Resistor 3M9 (0402) on place of R47
4. Solder Crystal SC12S-12.5PF20PPM above Resistor 3M9

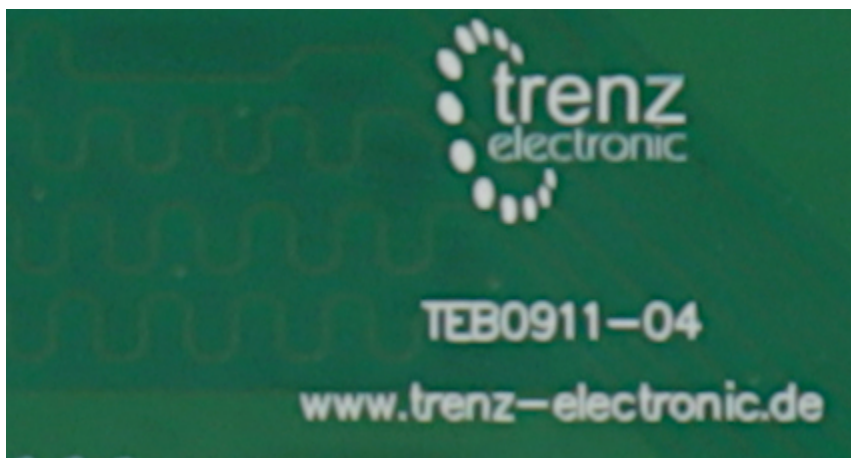
- The module revision number is printed on the top side of the PCB:
