PCN-20190829 TEI0009-02 Under Voltage Protection Change

| PCN Number | PCN-20190830 |
| Title | TEI0009-02 Under Voltage Protection Change |
| Subject | Trenz Electronic TEB0724 Hardware Change |

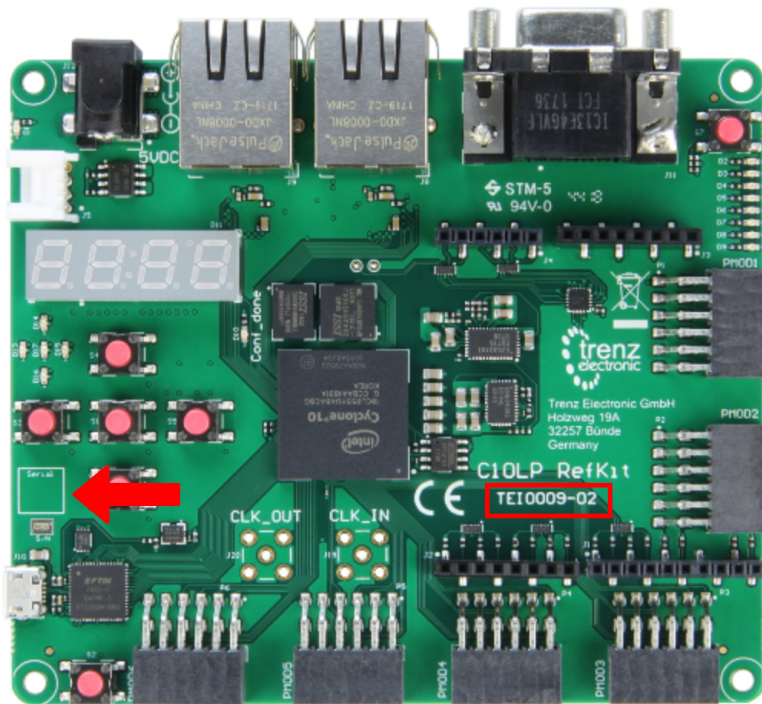
Method of Identification

The Serial number is written on a white QR Code sticker and placed on the top side of the PCB within the white frame. The model code and revision number (TEI0009-02) are printed on the top side of the PCB.
