SD Card Interface

Zynq PS SDIO

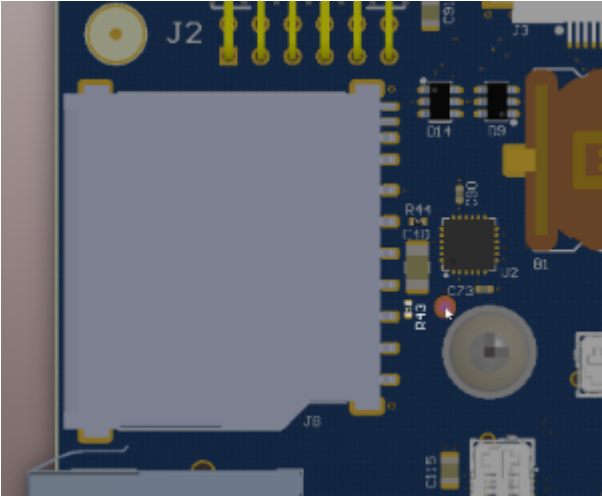
TE0701-05 Serial number: TBD
TE0703

TE0701 and TE0703 have pullup resistor on CMD line, which has been removed since:

Base	CMD pullup Resistor R43	Removed since
TE0701

This extra pullup may cause problems in some special cases with some SD Cards. As example hama micro-SD Card when used with PS7 SDIO MIO pullups enabled and R43 loaded had sporadic initialization problems on TE0703, removing R43 solved the issue.
