# SD Card Interface

## Zynq PS SDIO

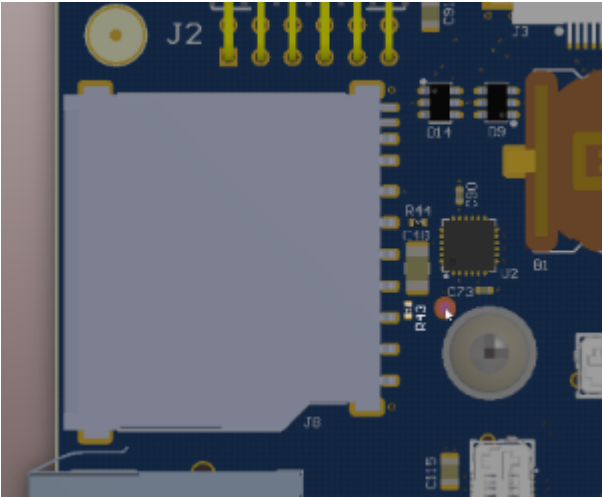
TE0701 and TE0703 have pullup resistor on CMD line, which has been removed since:

This extra pullup may cause problems in some special cases with some SD Cards. As example hama micro-SD Card when used with PS7 SDIO MIO pullups enabled and R43 loaded had sporadic initialization problems on TE0703, removing R43 solved the issue.

Some other designs and boards that use TXS02612 may have pullup on CMD, this is incorrect as per TXS02612 datasheet. Xilinx ZC702 board that uses SDIO level shifter with similar technology has the CMD pullup in schematic with marking "DNP" do not populate.
